## **SITE VISIT REPORT**

### **Geotechnical Investigations, Old Harbour Bay, St. Catherine**

Ref. No: 2014-14017-BL00010

Inspection date: 27 June 2014

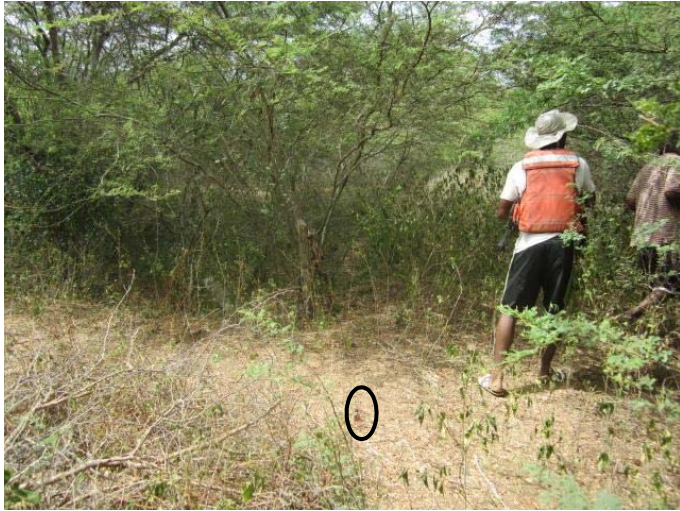
**Figure 1:** a) Photo with circle indicating survey point

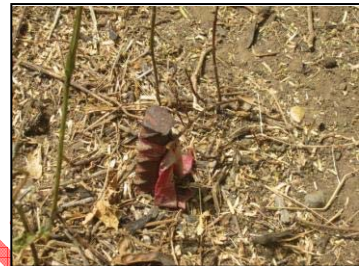
**Figure 2:** Photo showing close up of survey peg

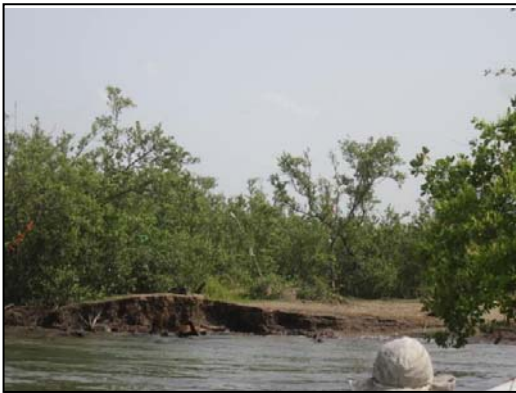
**Figure 3:** Photo showing road/pathway created prior to CHEC's involvement in the geotechnical survey

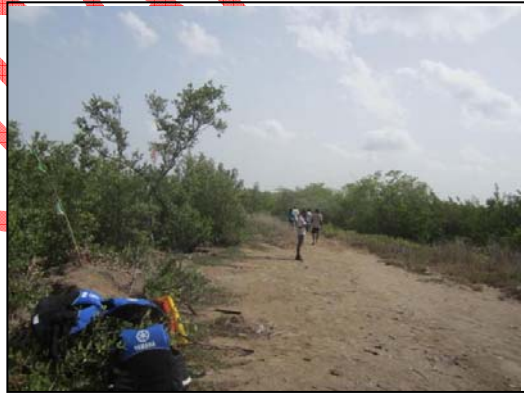
**Figure 4:** Photo showing road/pathway created prior to CHEC's involvement in the geotechnical survey

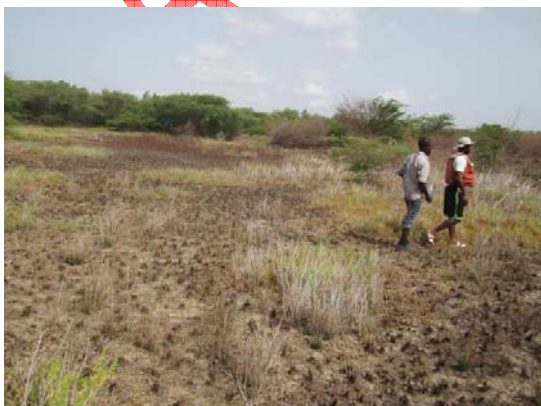
No geotechnical work was observed. Burning was observed along the pathway to points Z16 and Z17 (coordinates prior to amendment) (see appendix). Though this is a dry forest, there is reason to believe that some fires may be anthropogenic. Other land based coordinates that were mentioned prior to amendment were not observed as they were on private property; private property lines were indicated by the presence of a house and fenced off region. Sea based coordinates had been checked prior to this assessment.

**Figure 5:** Photo showing land was burnt

Continue monitoring this site and maintain contact with locals within the area so that operation date is fully observed and proper sanctions can be made if necessary. Once the permit has been issued a letter reminding CHEC of the documents required prior to operation (as stated by permit 2014-14017-BL00010) should be sent to CHEC.

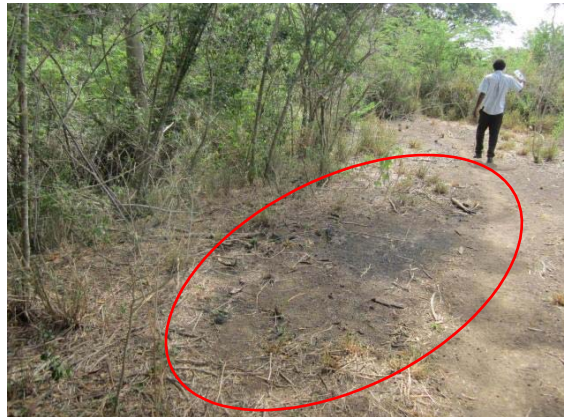
**Figure 6:** Photo showing land was burnt; burnt area highlighted with a red circle

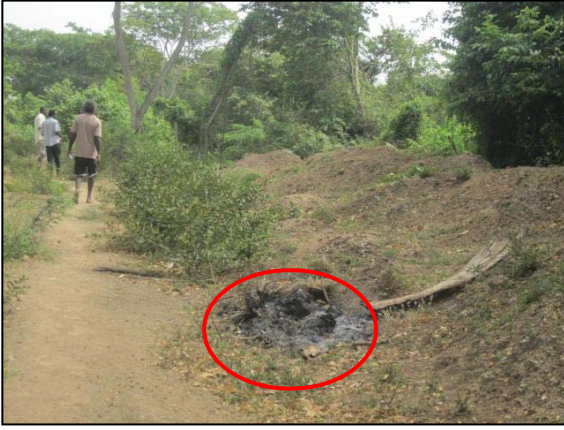
**Figure 7:** Photo showing land was burnt; burnt area highlighted with a red circle

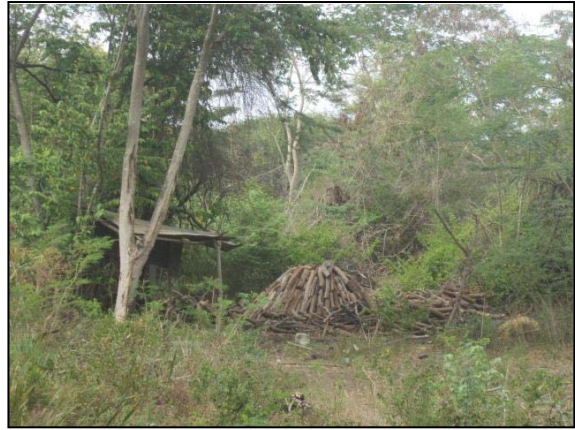
**Figure 8:** Photo showing evidence of deforestation. Possibility that this is where charred wood in figures 6 and 7 were taken from
